**Comparative study on microstructure and corrosion behavior of
nanostructured hydroxyapatite coatings deposited by high velocity oxygen
fuel and flame spraying on AZ61 magnesium based substrates.**

Comparative study on microstructure and corrosion behavior of nanostructured hydroxyapatite coatings deposited by high velocity oxygen fuel and flame spraying on AZ61 magnesium based substrates

Magnesium, Corrosion rate, Hydroxyapatite, HVOF, Flame spraying

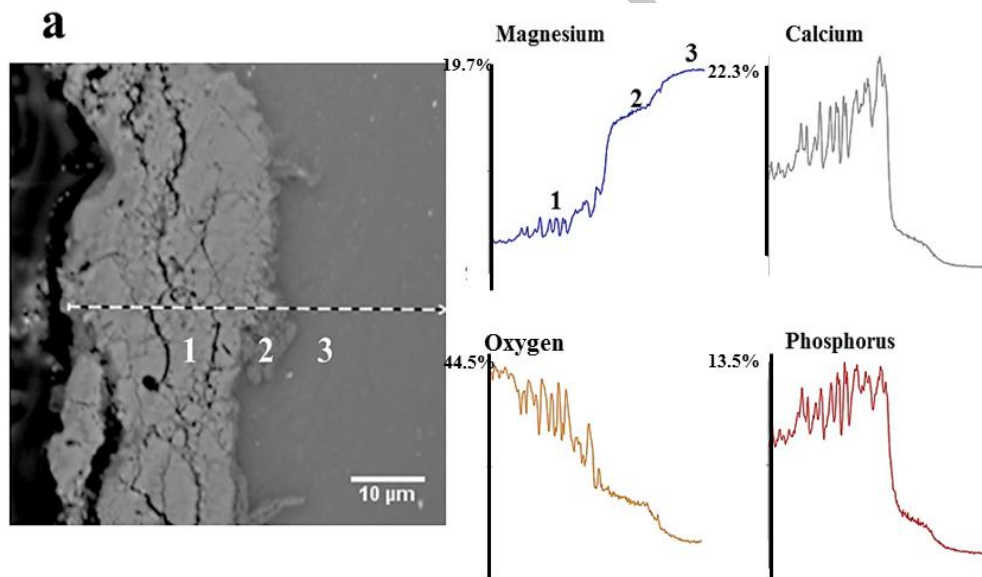
Fig.3. Line-scan elemental analysis of a) HVOF and b) Flame sprayed coatings
